■ conservation

Conservation in the Sculpture Garden

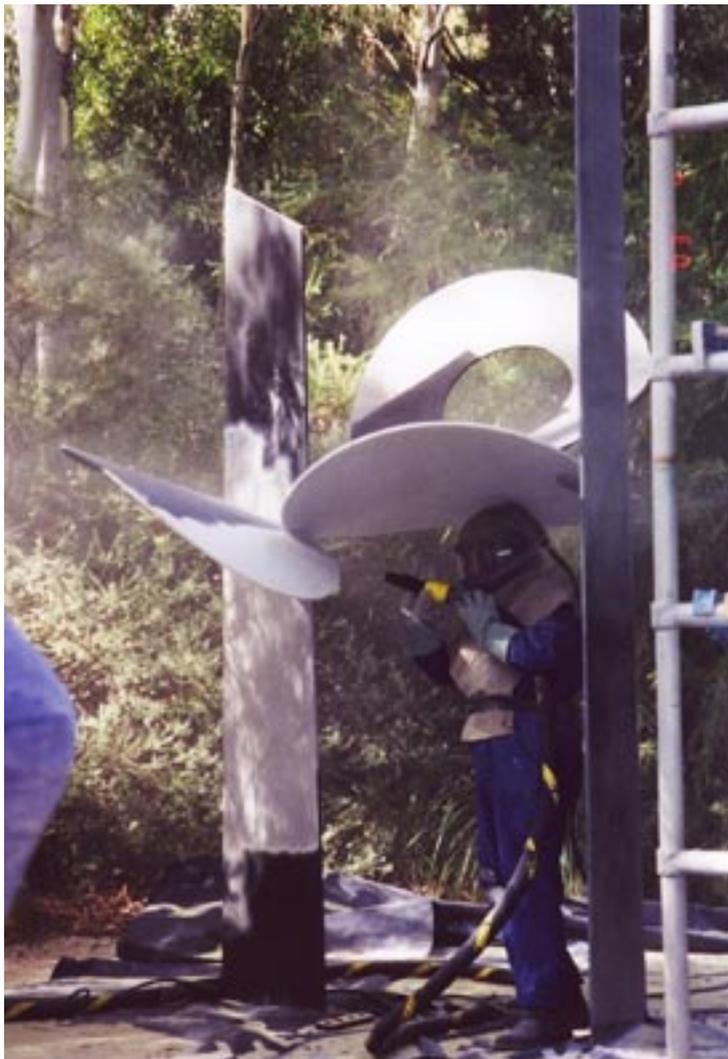
Sandblasting Inge King's *Temple gate*

The two painted steel sculptures, *La bobine* by the American artist Alexander Calder and *Temple gate* (steel and aluminium) by the Australian artist Inge King, required repainting. The paint systems had begun to fail; in some areas moisture had infiltrated the paint coating and prolonged exposure to ultraviolet radiation had faded the paintwork, resulting in the formerly black paint appearing as a patchy grey colour. In conservation terms the paint had failed aesthetically and was interfering with the artist's intention for the presentation of the work. In the case of *Temple gate* we were fortunate to be able to consult with the artist. Inge King's primary concern was that

the sculpture should not appear grey as this compromised the integrity of the work, which was intended to be a solid black colour.

Both of the painted steel sculptures required removal of the old paint by controlled abrasive blasting and applying a new, durable paint system. After removing the paint back to the bare metal a zinc-rich primer paint was used, which acts to provide long-term corrosion protection to the mild steel. The type of paint system was selected for its longevity in outdoor exposure as a 10-year life-span was specified by the Gallery. The sculptures require regular maintenance, including washing dirt and bird droppings off the surface, and reapplying protective coatings to the sculptures, when they show signs of degrading. An ongoing maintenance regime will ensure that the works continue to represent the intentions of the artists and reduce the need for future large-scale restoration work.

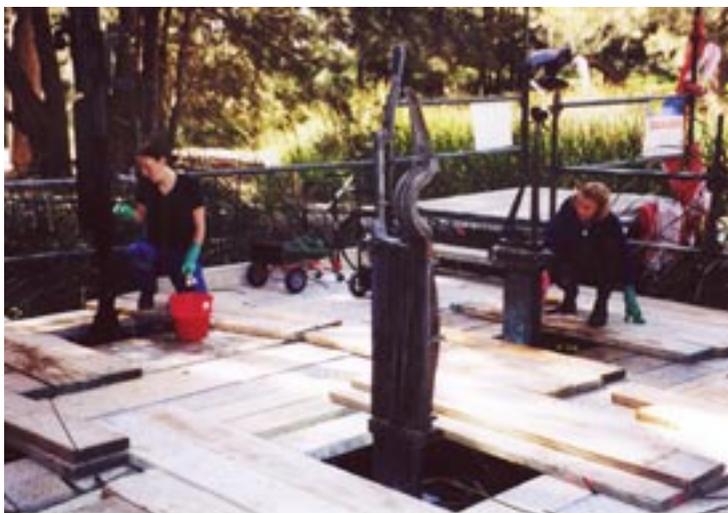
(detail) White pustules on Robert Klippel's *Group of eight bronzes*

Scaffolding erected to undertake conservation on Robert Klippel's *Group of eight bronzes*

The full extent of treatment for the *Group of eight bronzes* was devised after consultation with the Gallery's Conservation and Curatorial departments. Due to the water restrictions enforced by recent drought conditions, it was not viable to drain the pond, so a scaffolding floor needed to be erected above the water level. The sculptures were thoroughly washed and the white pustules mechanically removed. The green (copper) corrosion was removed with a chemical poultice, which acts to soften the bond between the corrosion and the metal. One sculpture required repatination, involving the use of chemicals and heat to artificially create a brown surface colouration (patina), to match the other works. A protective coating of microcrystalline wax was applied. Holes and porosity in the metal were filled with adhesives to make the sculpture watertight. A drainage hole was drilled in the lowest point of the water catchment area to keep the area dry.

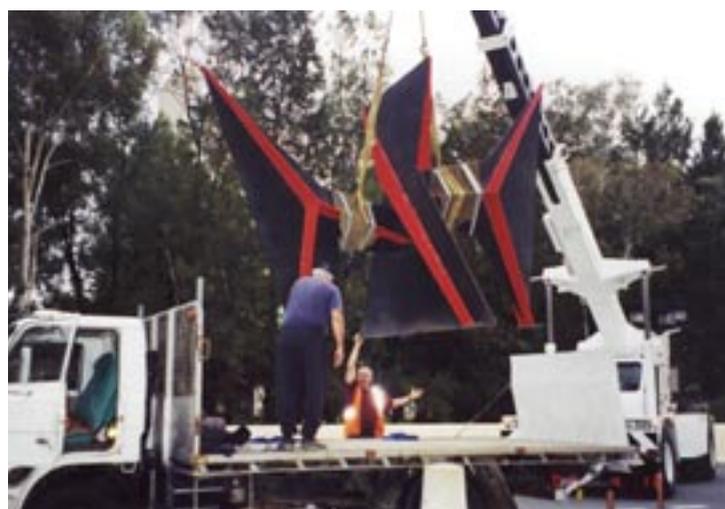
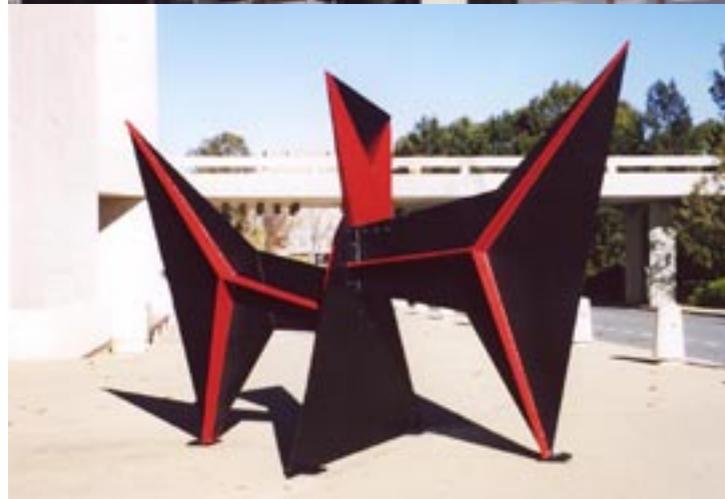
Installing Alexander Calder's *La bobine* following treatment
